# PRELIMINARY REPORT

## INTERNAL PERIMETER WALLS MOISTURE SCAN

SAMPLE \*\*\* NOT A REAL PROPERTY \*\*\* SAMPLE

11 October 2013

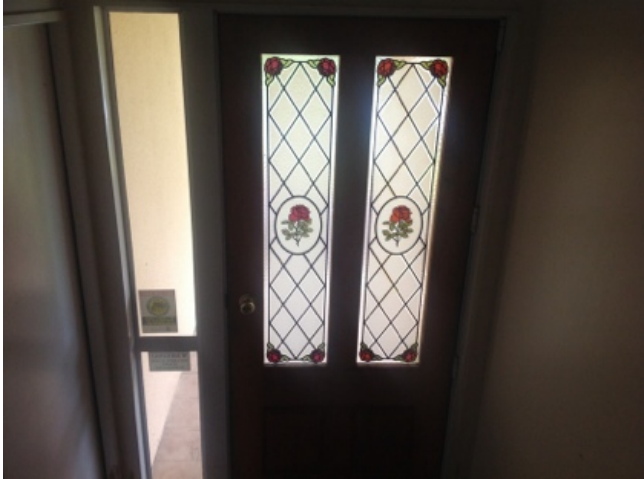
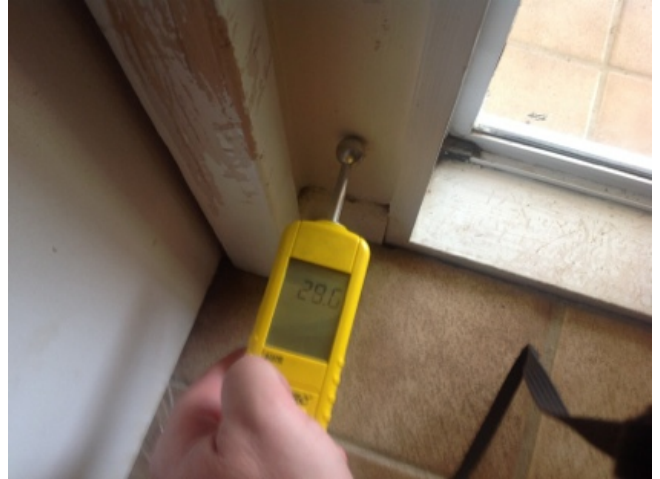
Hallway

No elevated readings noted

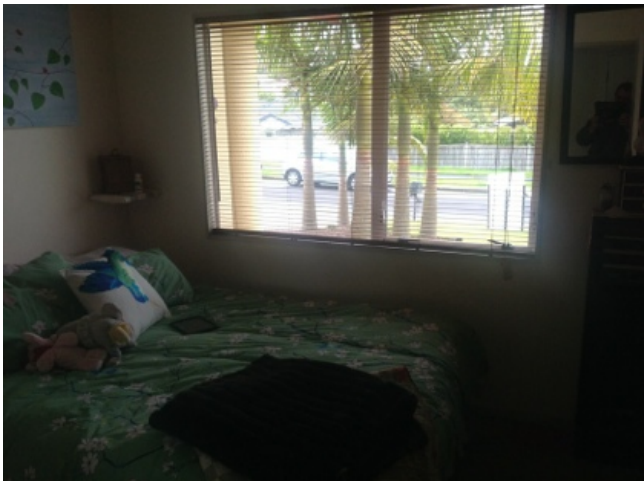
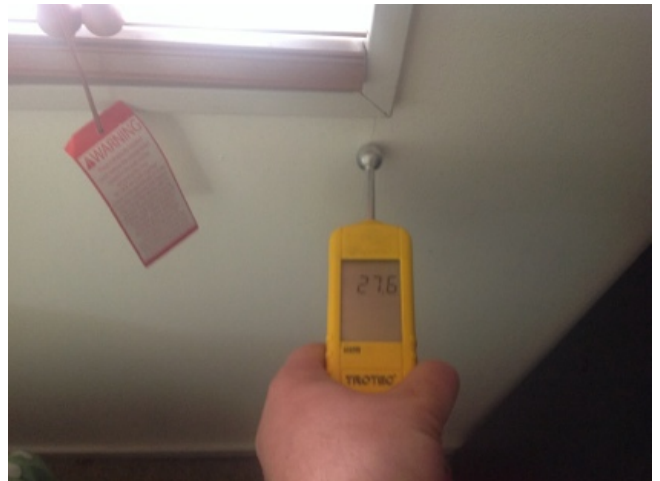
Bedroom

No elevated readings noted

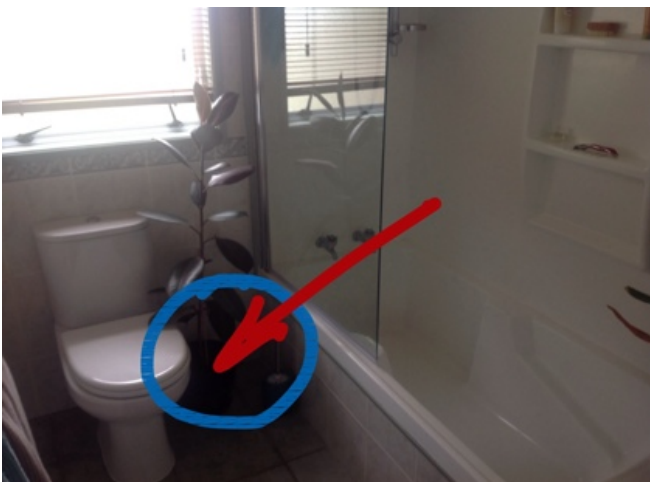
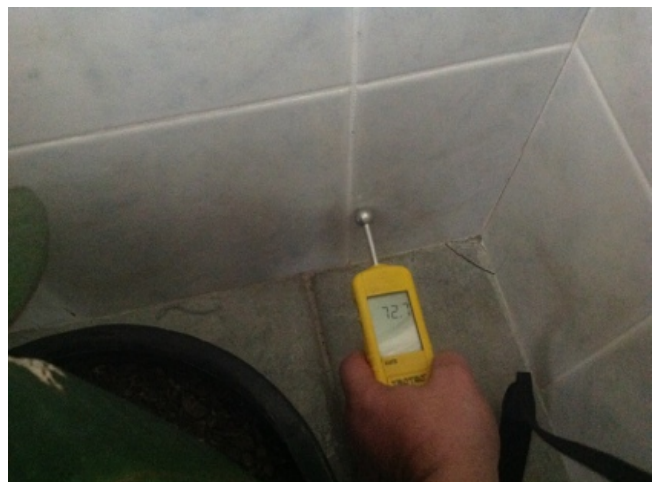
Bathroom

Elevated readings noted

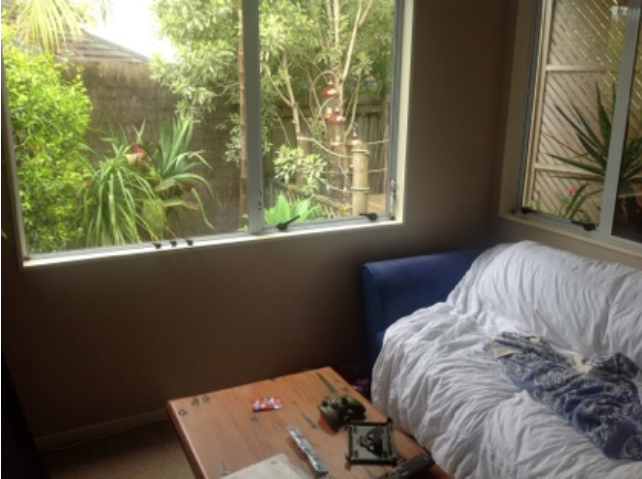
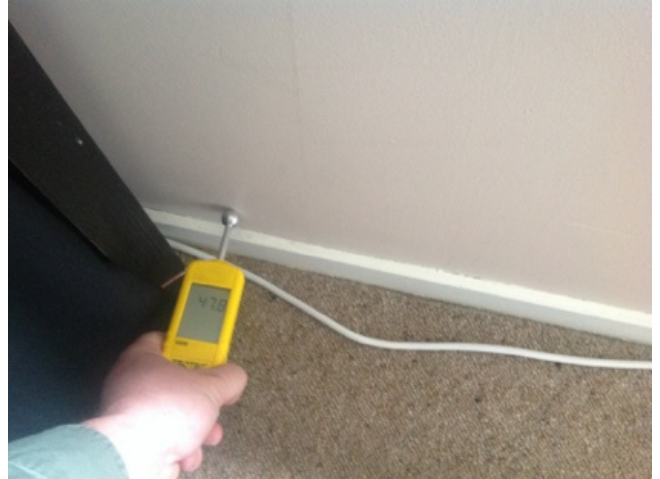
Bedroom

No elevated readings noted

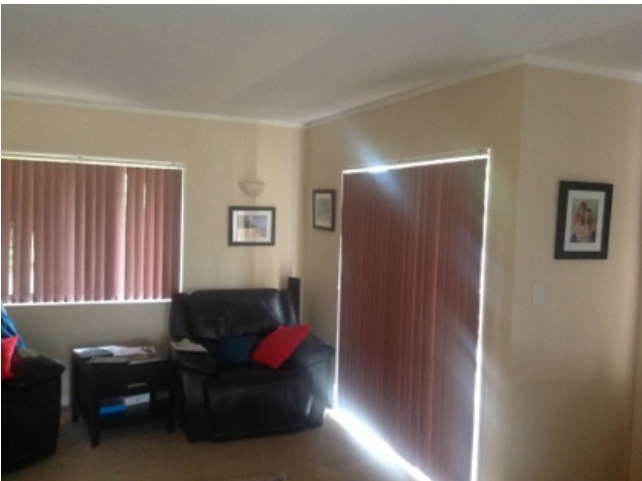
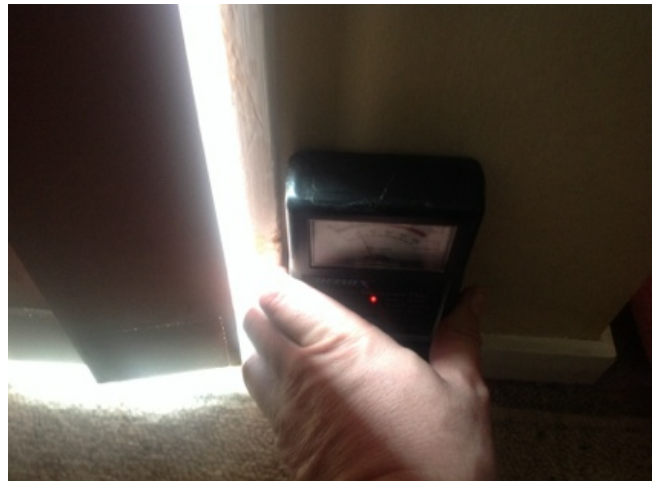
Lounge

No elevated readings noted

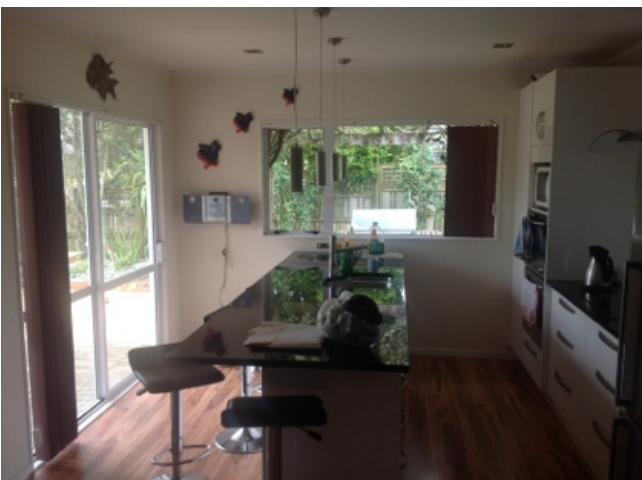
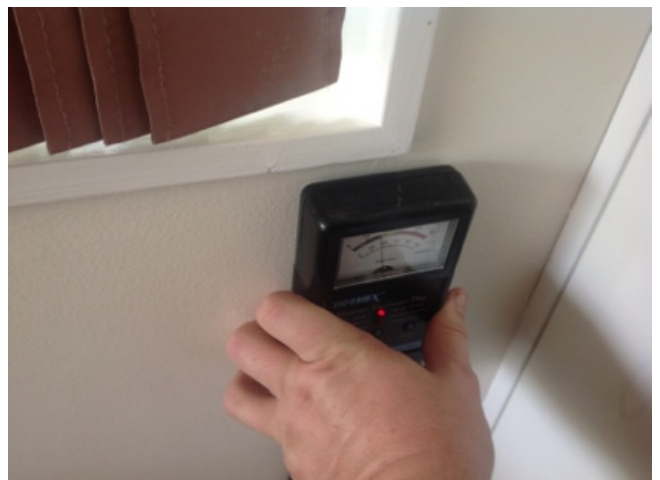
Kitchen

No elevated readings noted

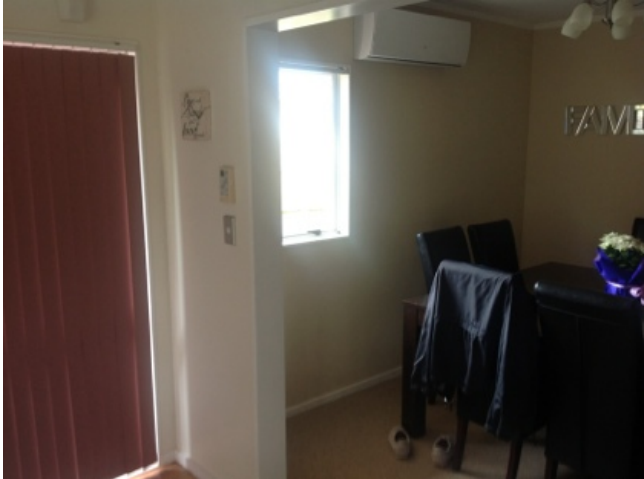
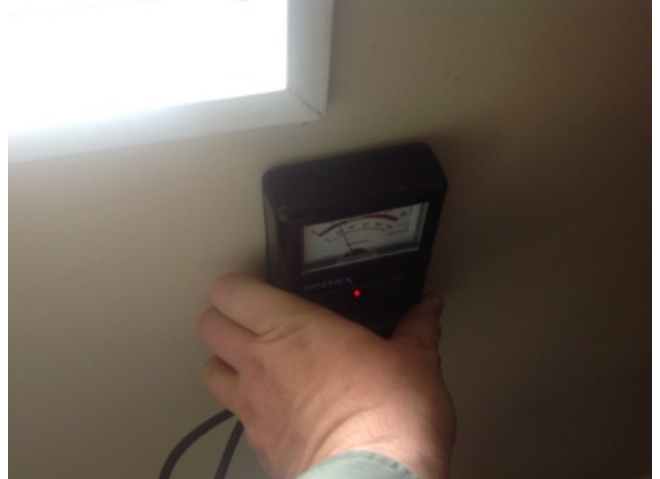
Dinning

No elevated readings noted

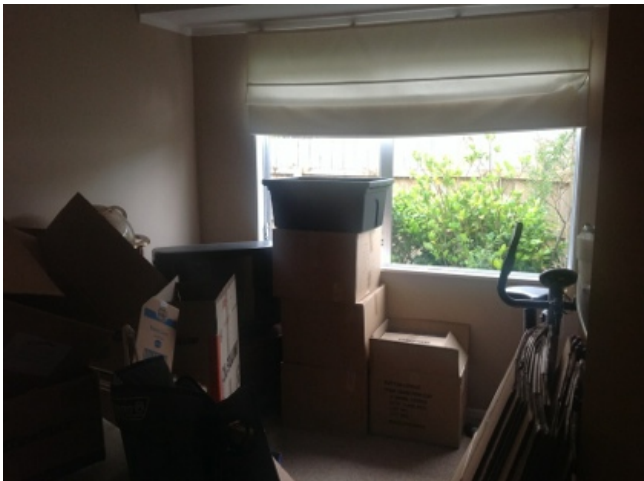
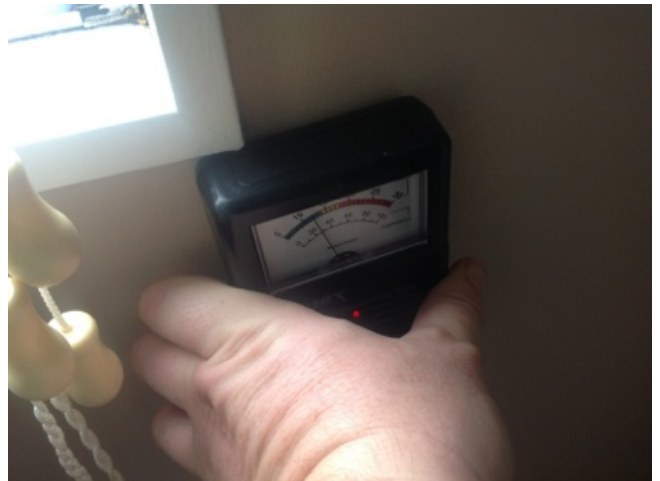
Bedroom

No elevated readings noted

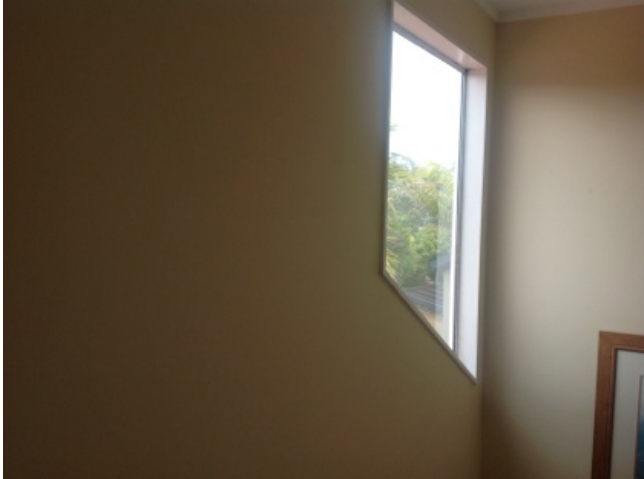
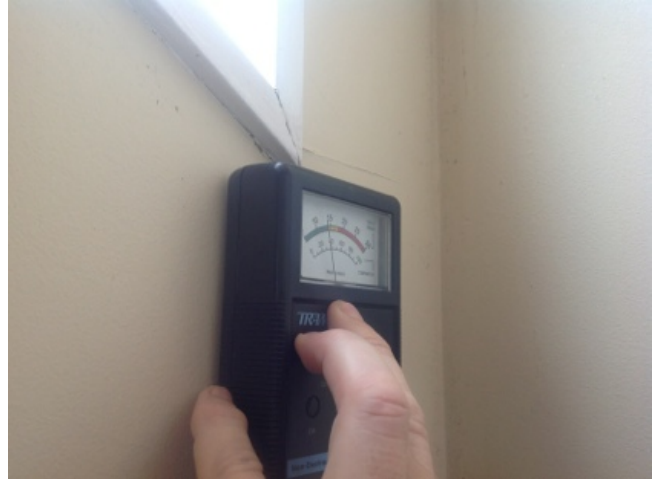
Stairs

No elevated readings noted

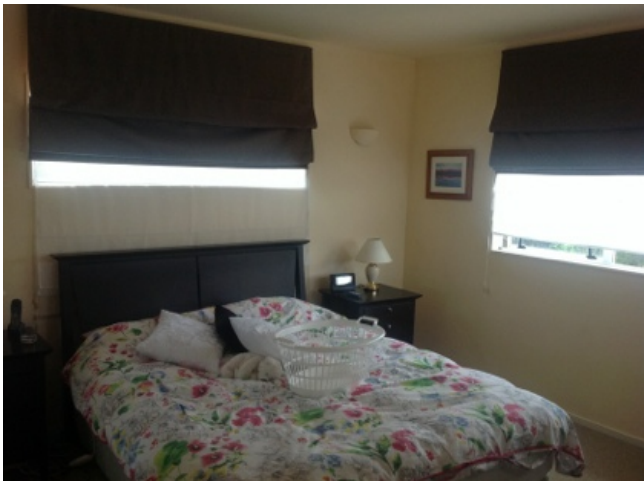
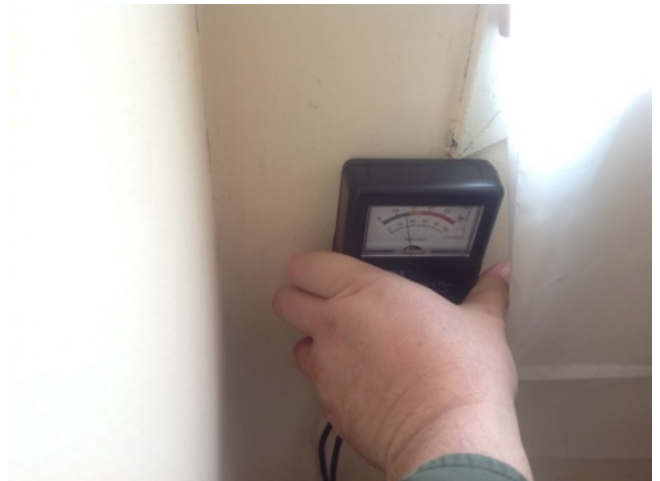
Bedroom

No elevated readings noted

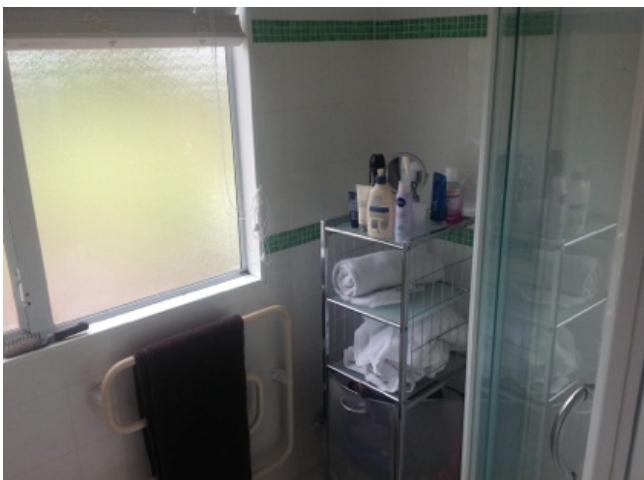
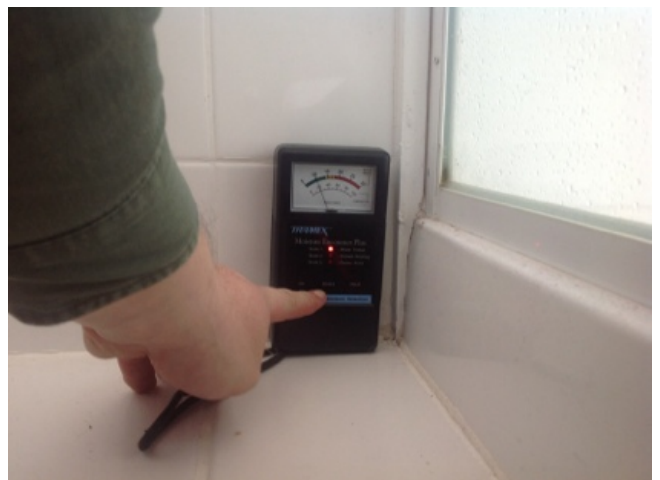
Bathroom

No elevated readings noted

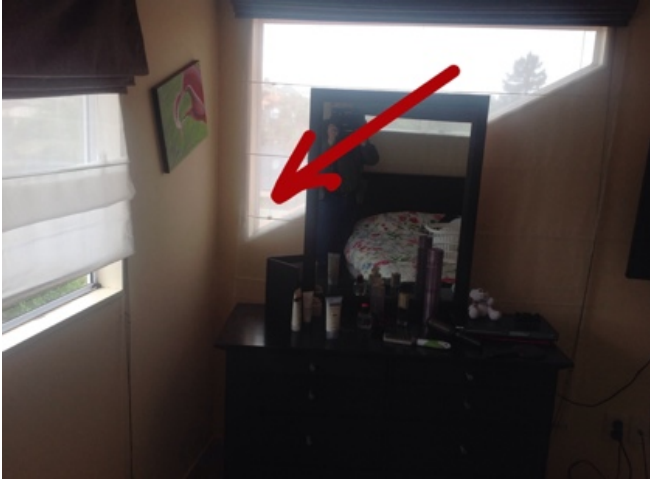
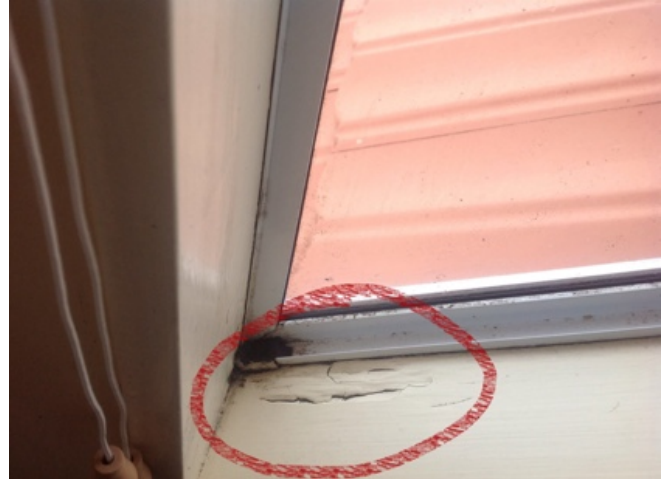
Bedroom

Water damage

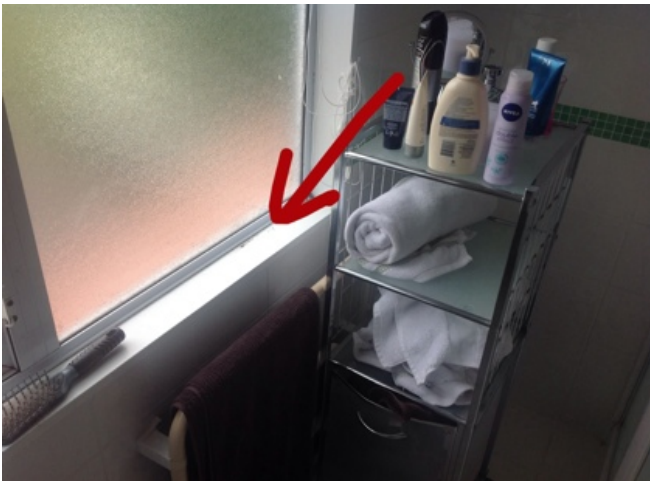
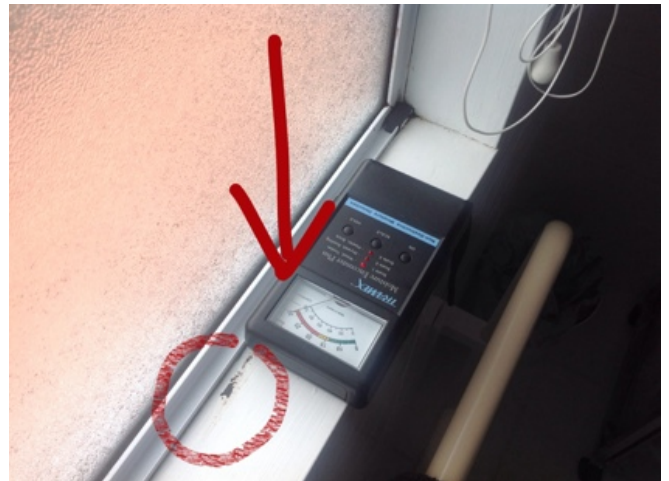
Bathroom

Water damage

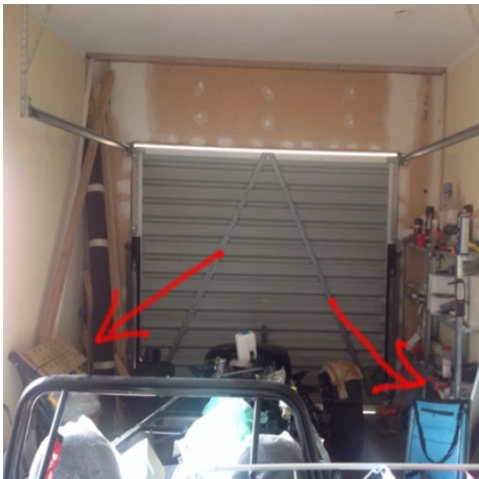
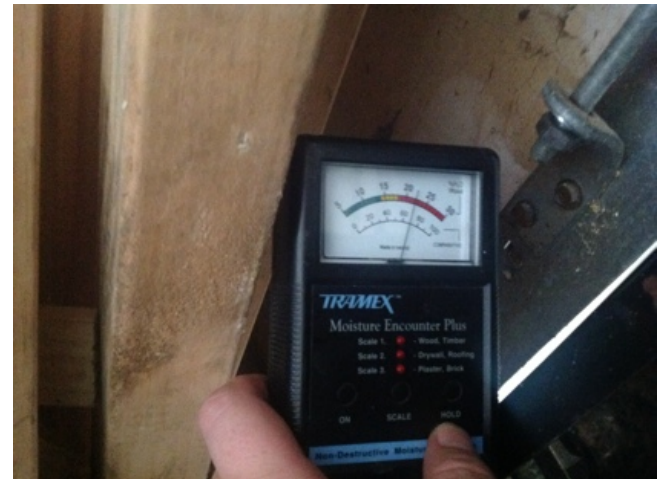
Garage	<input type="checkbox"/> Mould	<input checked="" type="checkbox"/> Mark(s)	<input type="checkbox"/> Damage	<input checked="" type="checkbox"/> Attention	HIGH readings noted
Laundry	<input type="checkbox"/> Mould	<input type="checkbox"/> Mark(s)	<input type="checkbox"/> Damage	<input type="checkbox"/> Attention	No elevated readings noted
N/A	<input type="checkbox"/> Mould	<input type="checkbox"/> Mark(s)	<input type="checkbox"/> Damage	<input type="checkbox"/> Attention	N/A
N/A	<input type="checkbox"/> Mould	<input type="checkbox"/> Mark(s)	<input type="checkbox"/> Damage	<input type="checkbox"/> Attention	N/A
Bedroom	<input type="checkbox"/> Mould	<input type="checkbox"/> Mark(s)	<input type="checkbox"/> Damage	<input type="checkbox"/> Attention	No elevated readings noted
Bedroom	<input type="checkbox"/> Mould	<input type="checkbox"/> Mark(s)	<input type="checkbox"/> Damage	<input type="checkbox"/> Attention	No elevated readings noted

High readings noted
